Manhole Inspection Summary

Manhole # S31AA2008MH

Location Address: **103 NORTHERN PKWY**

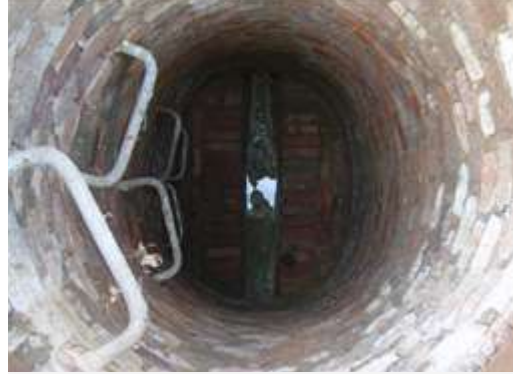
Top View

Channel debris.

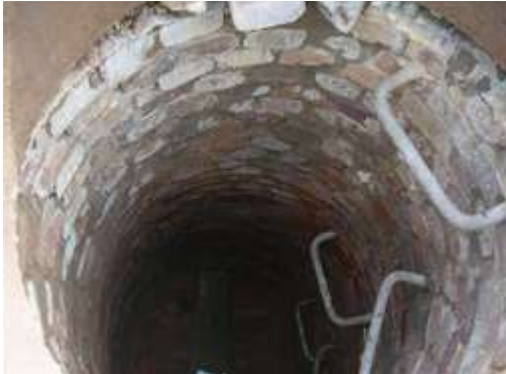
Defect

Frame leaks. Adjustment deterioration, loose brick and infiltration. Corbel and Barrel infiltration.

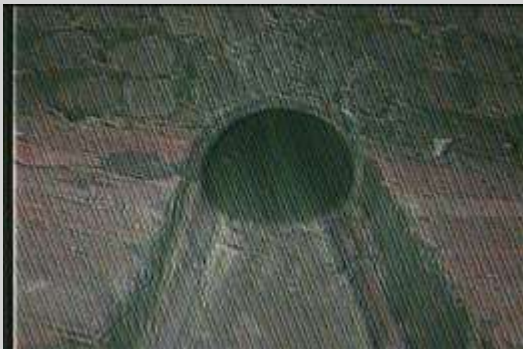
8 in. Circular Gravity Sewer Pipe In @ 6 O'Clock

Barrel deterioration and infiltration.

Infiltration: **None** Pipe Seal Cond: **Cracked**
